Pressure Vessel Assessment Report

Client:	Total Energy	Location:	Blackwell OK	Date:	7/23/2013
Contact:		Integrity Mgmt. Advisor:	Chuck Easterbrooks - API 510 #2212		
Cc:		API / UT Inspector:	Robert Van Pelt-API 510# 40899		
Vessel Description:	Propane Storage Tank				
Vessel Identification:	SN-1534

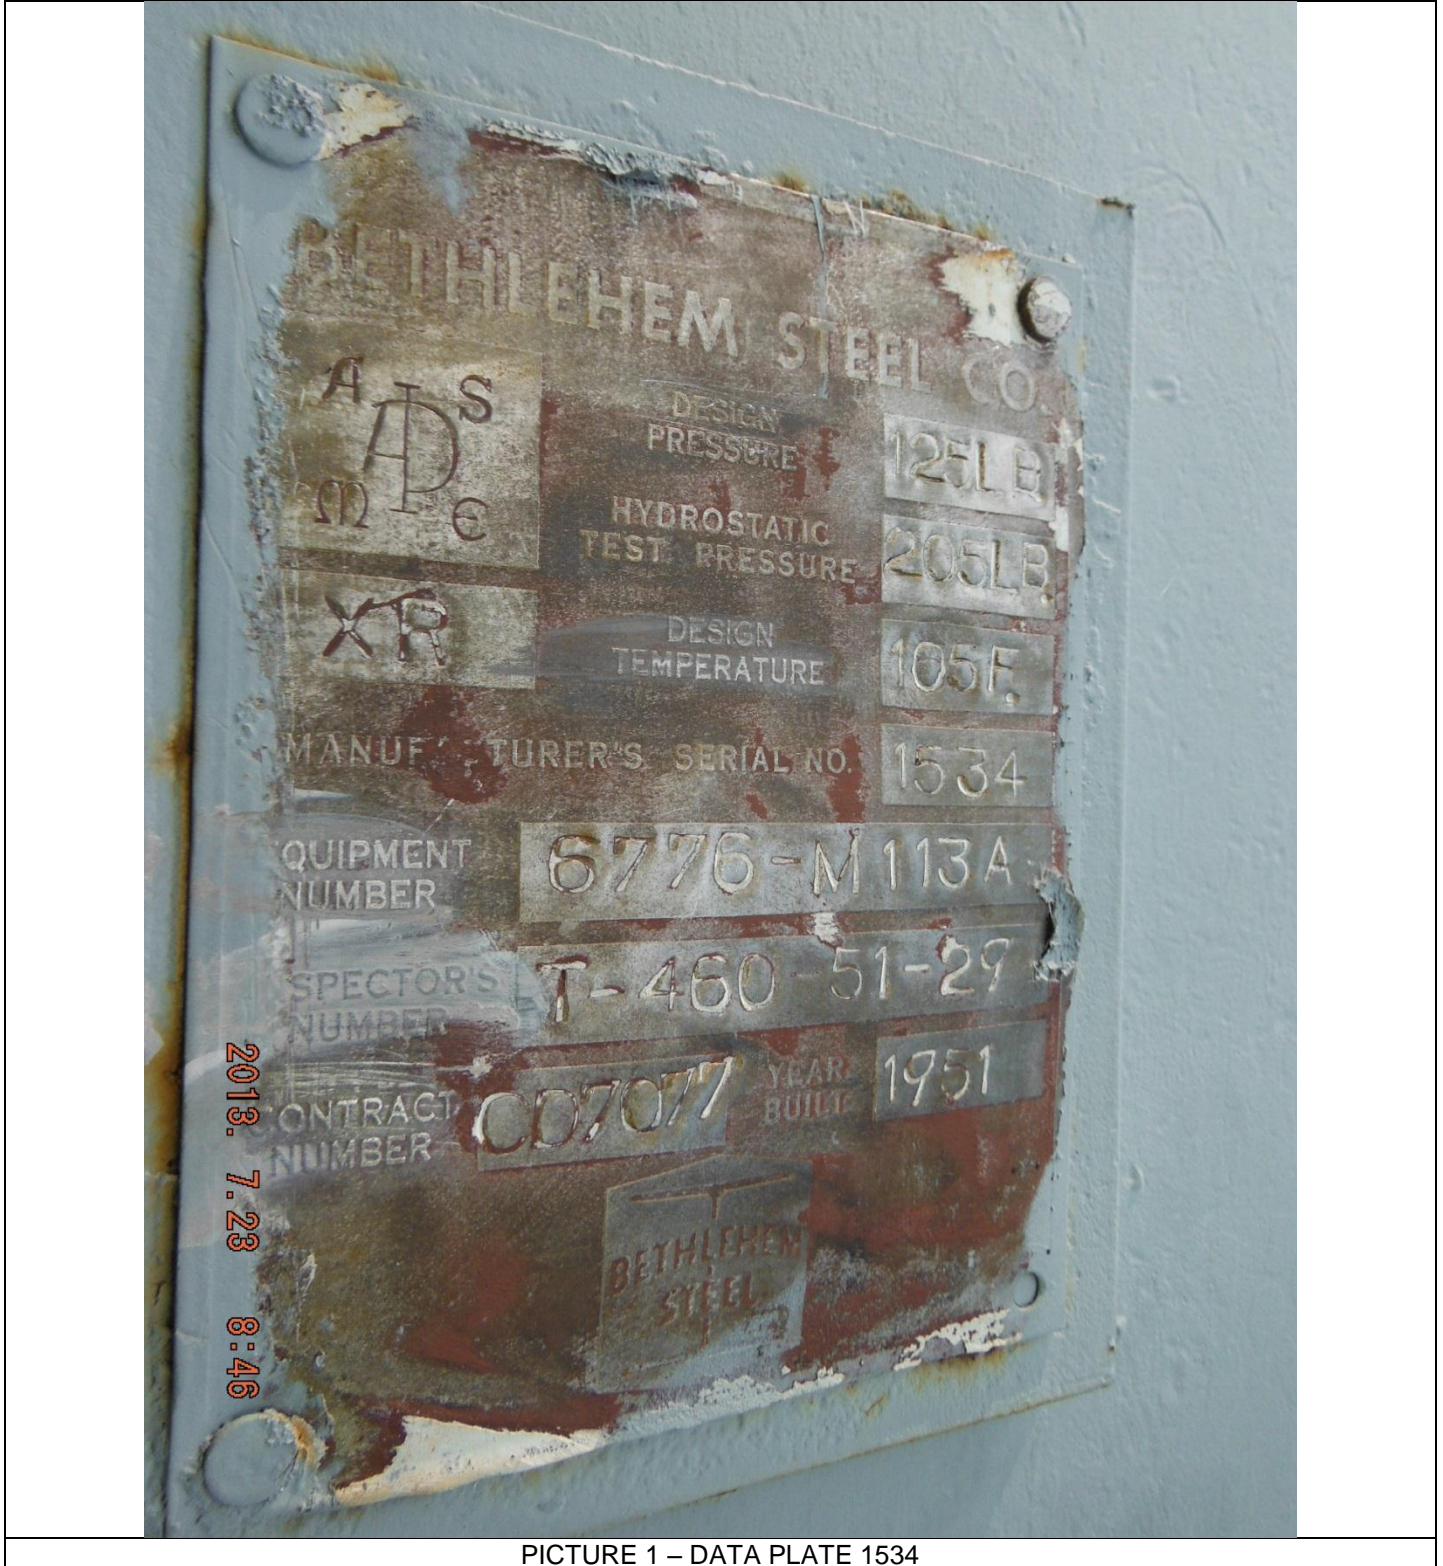
PICTURE 1 – DATA PLATE 1534

The data plate was intact and legible.

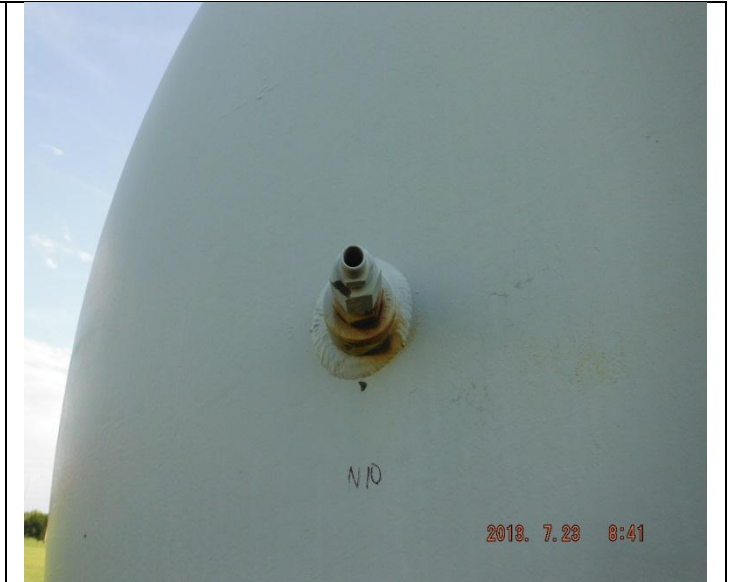
There is scattered coating failure over the entire vessel. There is mild active oxidation associated with the coating failure with negligible wall loss. There were access platform clips welded to the shell but the platforms were not on site.

<p>2018. 7.23 8:41</p>
<p>Platform clips</p>	<p>Welded coupling</p>

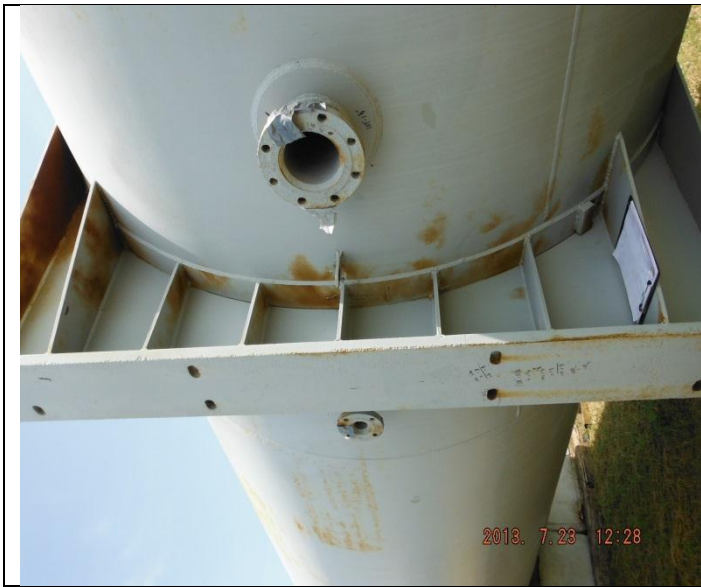
There are 3 saddles supports for this vessel. Each support has a reinforcement band ¼” thick by 9” wide completely encompasses the full circumference of the vessel. The supports are located near each end and in the center. There were no visible distortions and the supports appear to be in serviceable condition.

Saddle Support

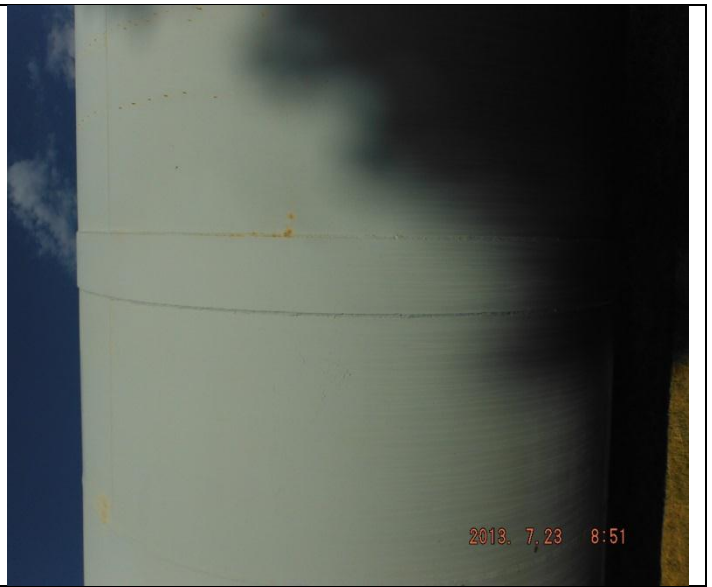
Reinforcement strap for saddle

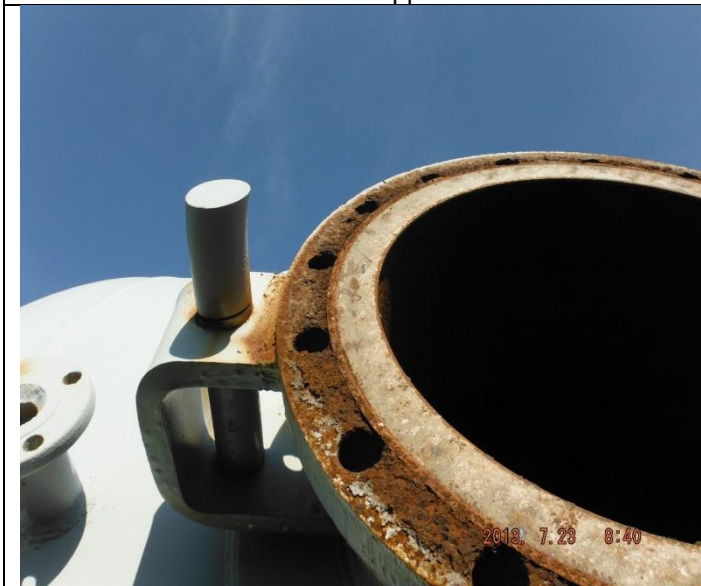
The manway had a heavy atmospheric scale build up on the flange area around the OD of the raised face sealing surface. The sealing surface was in serviceable condition. The scale can be scraped off with a hand scraper. The manway davit arm had been cut off previously leaving only the davit arm hinge clip and a partial remnant of the davit arm inserted into the clip.

Davit Arm bracket

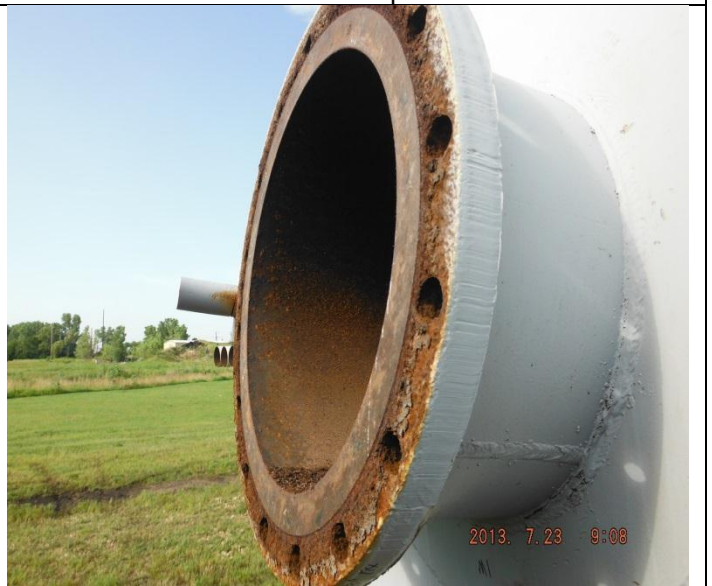
Man Way

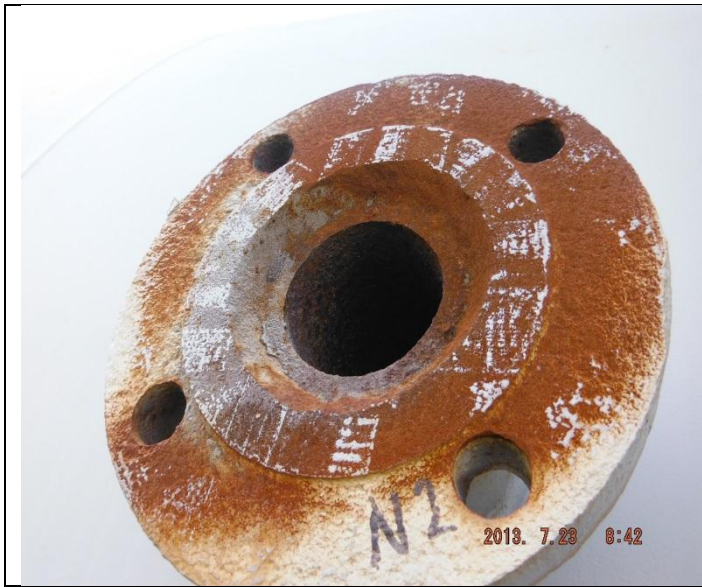
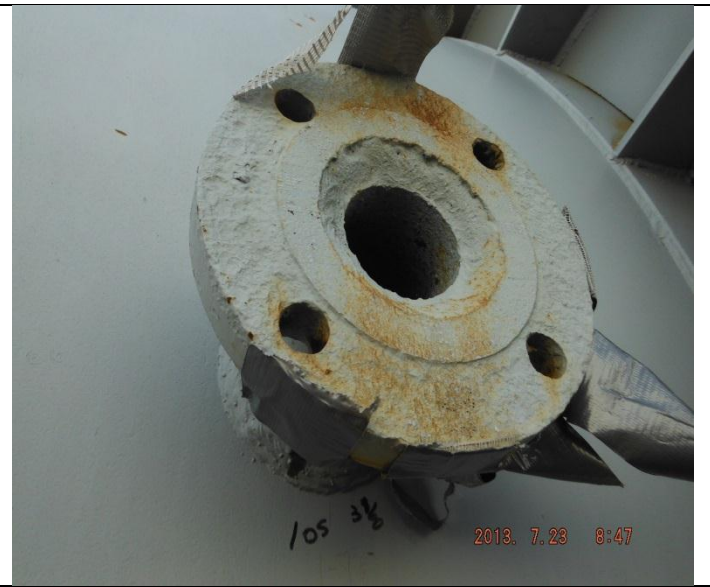
The nozzles necks were in serviceable condition however the flange sealing surfaces had a tightly adhered combination of atmospheric scale and paint approximately 20 mils thick. The pitting was not evaluated on the sealing surface due to the heavy scale build up. Nozzle labeled N3 had a visible RMS finish under the heavy scale while all of the other flange seating surfaces had no visible serrations. There were reinforcement pads installed on the 6” nozzle and the manway. All the repads had metallic threaded plugs installed in their telltale holes. Inspection of the telltale holes could not be performed.

Corroded Flange Face

The vessel should be abrasively blasted and painted to mitigate future external corrosion. All flange gasket surfaces should be mechanically cleaned and evaluated to ensure suitability for service.

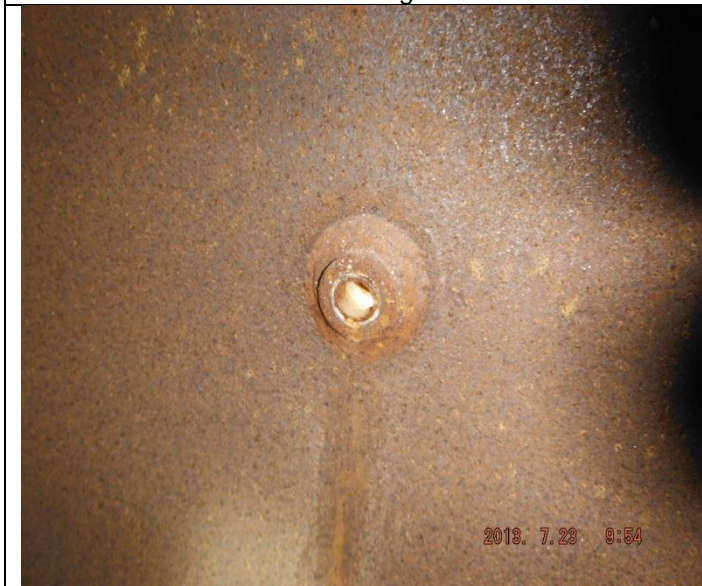
A 2" nozzle on the north east side had a valve and blind installed. Inspection of this nozzle was limited to the ID surface only, It had a heavy rust and scale build up which impeded the ID inspection of the surface. All nozzles, including threaded couplings, were internally back-welded and have some internal projection. All welds are full and complete with no visible porosity, cracking, or discontinuities that would affect the pressure retaining capabilities. Nozzle necks are free from debris and corrosion. All ID nozzle weld surfaces were comparable to the adjacent shell surfaces.

ID of welded coupling

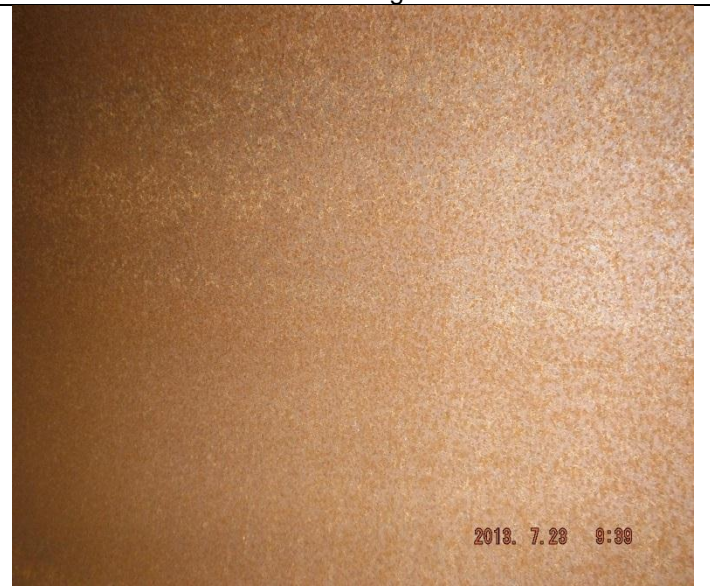
The shell internal surface was generally smooth with no measurable pitting. There was a light surface oxidation throughout the entire ID of the vessel. The welds were full profile and comparable to the shell surface ID. There are 3 internal stiffening rings welded to the shell for the entire ID circumference that are ½" thick X 6" in height.

ID of shell

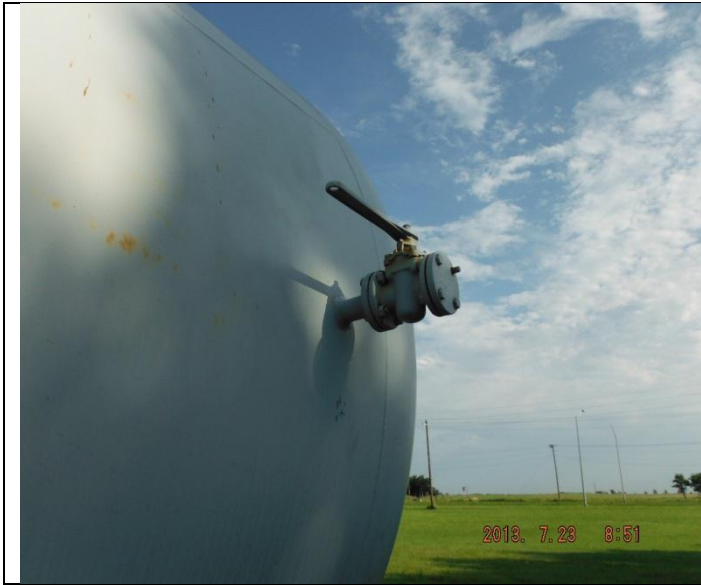
Valve bolted to flange

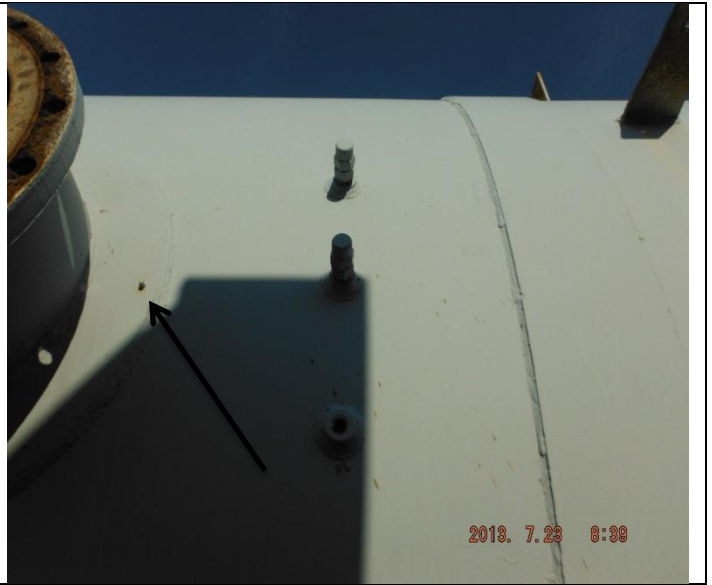
Repad plugged with threaded plug

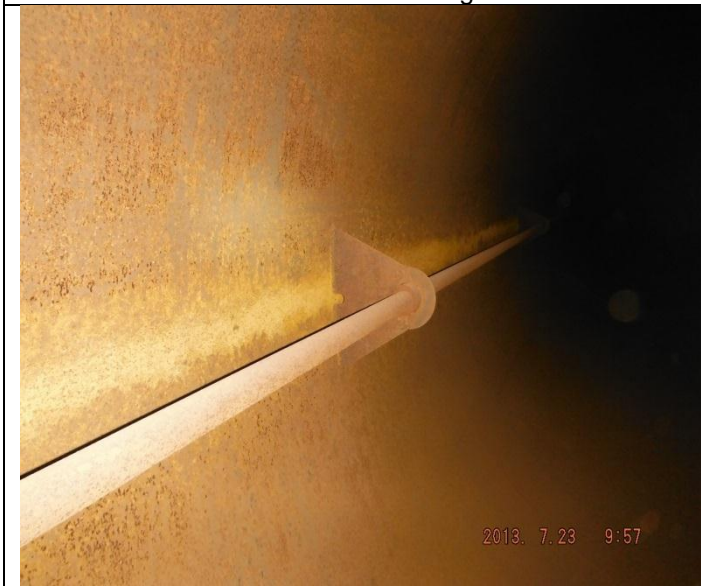
A distributor pipe was installed on the south west end of the vessel and traveled to the north for the entire length to the vessel. The north end of the distributor header (approximately 15 foot) had 1/16" holes on the bottom of the pipe. The holes were 2" apart in a linear row. 95% of the holes completely were plugged.

Distributor Pipe

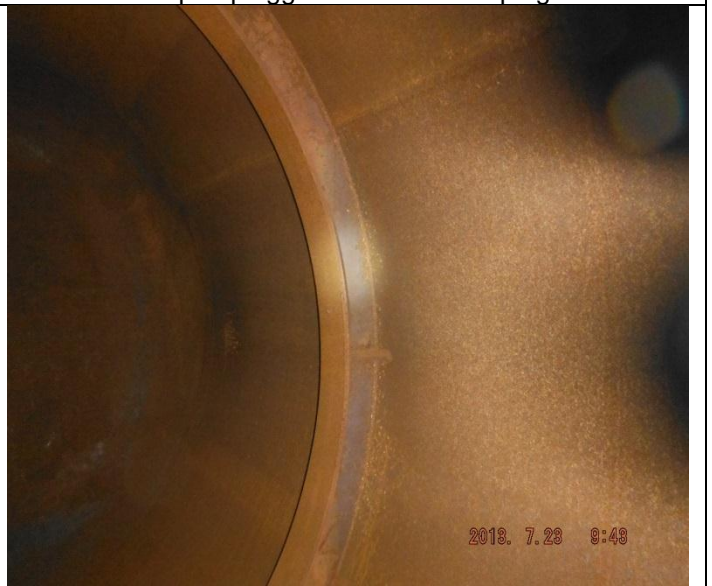
ID Stiffener support for saddles (typ 3)
